ELECTRICAL DEPARTMENT
ADMIRALTY ENGINEERING
LABORATORY
WEST DRAYTON, MIDDLESEX

THIN-PANELLED GLASS-FIBRE/RESIN CONTAINER MADE BY
PERMALI LTD. FOR SUBMARINE CELL TYPE
8000 - SHOCK.

REPORT NO. 2434/3206/31

A second experimental thin-panelled homogeneous glass-fibre/resin container made by Pernali Ltd., for cell Type 8000 has been subjected to shock test, the first container having failed. The shock resistance of the second container was satisfactory and the bulge of its side panel was less than that of the first.

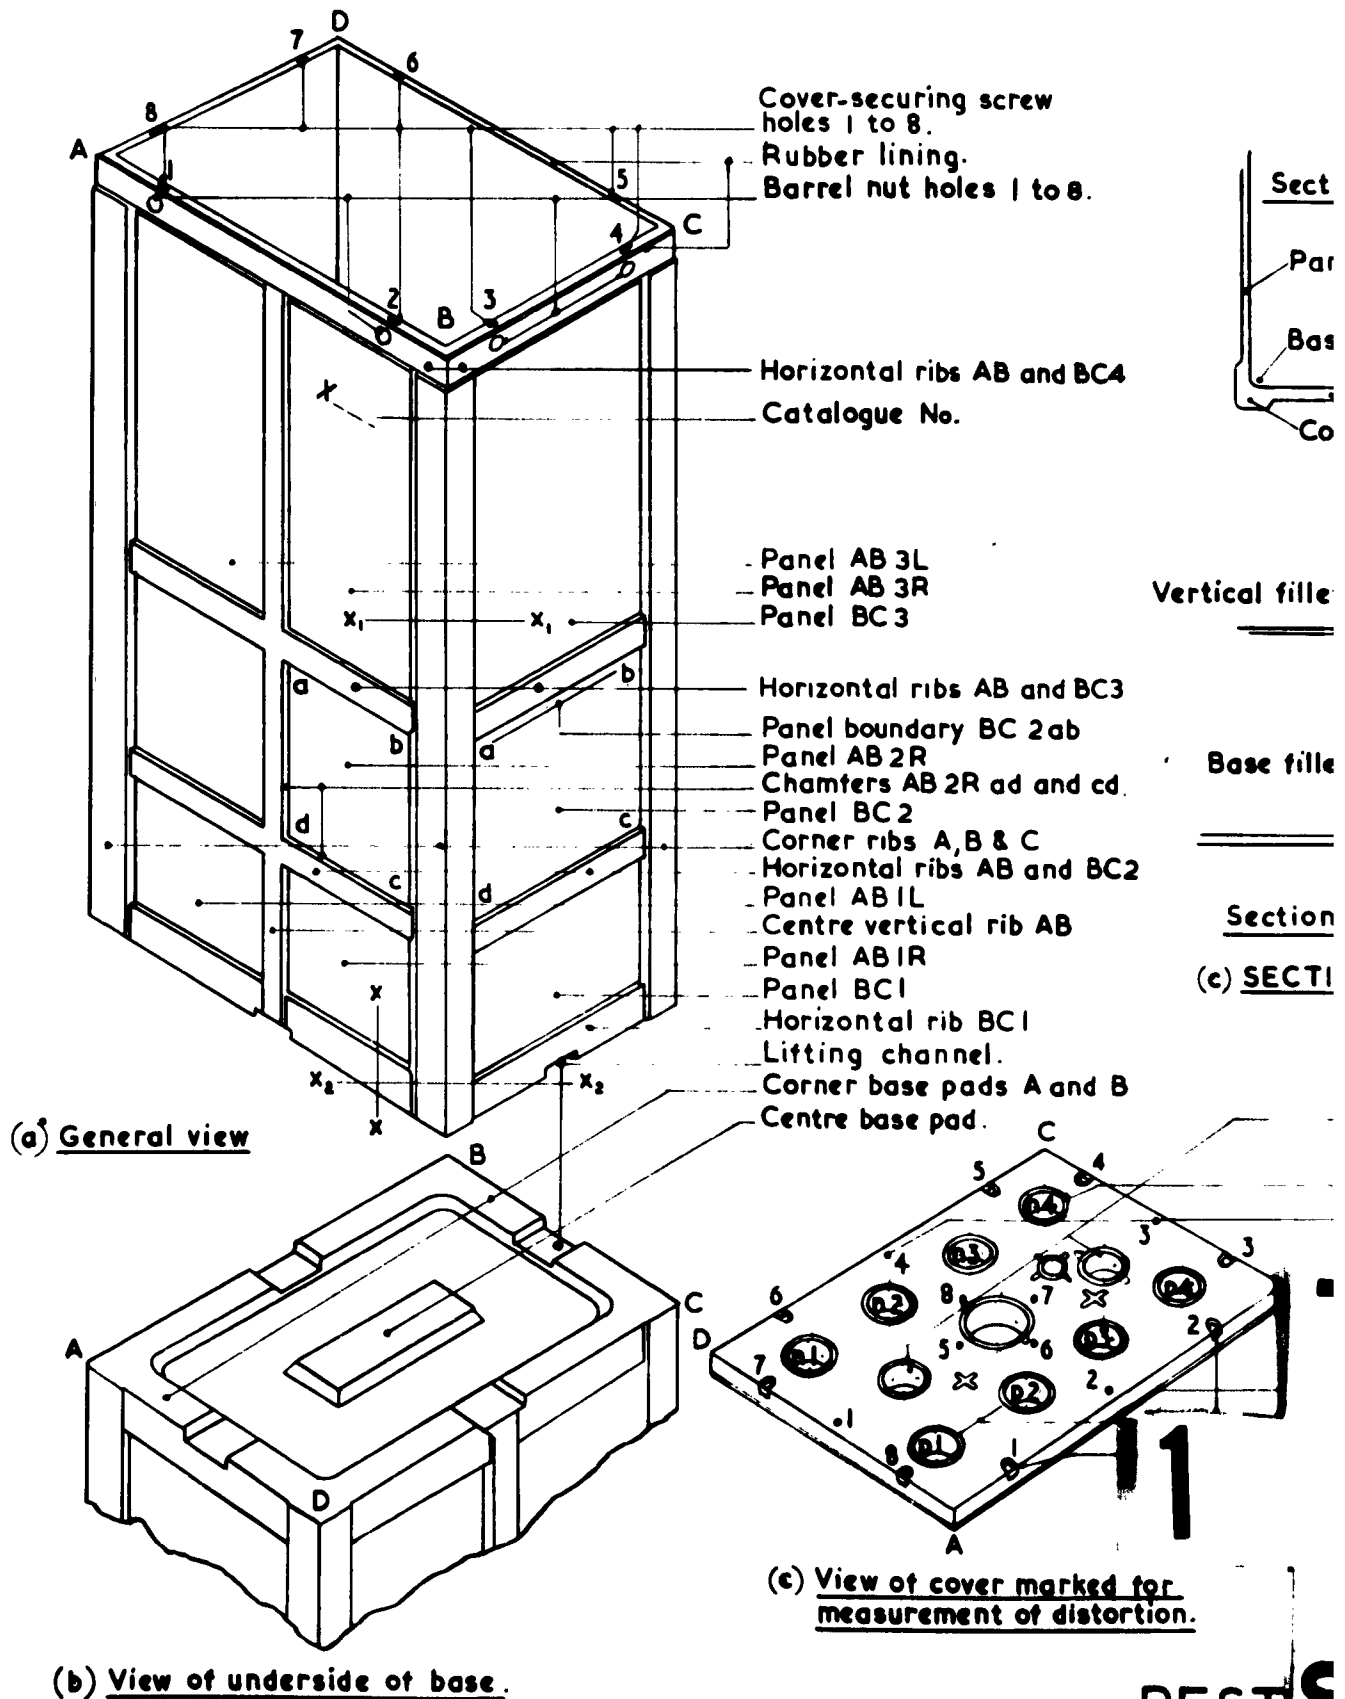
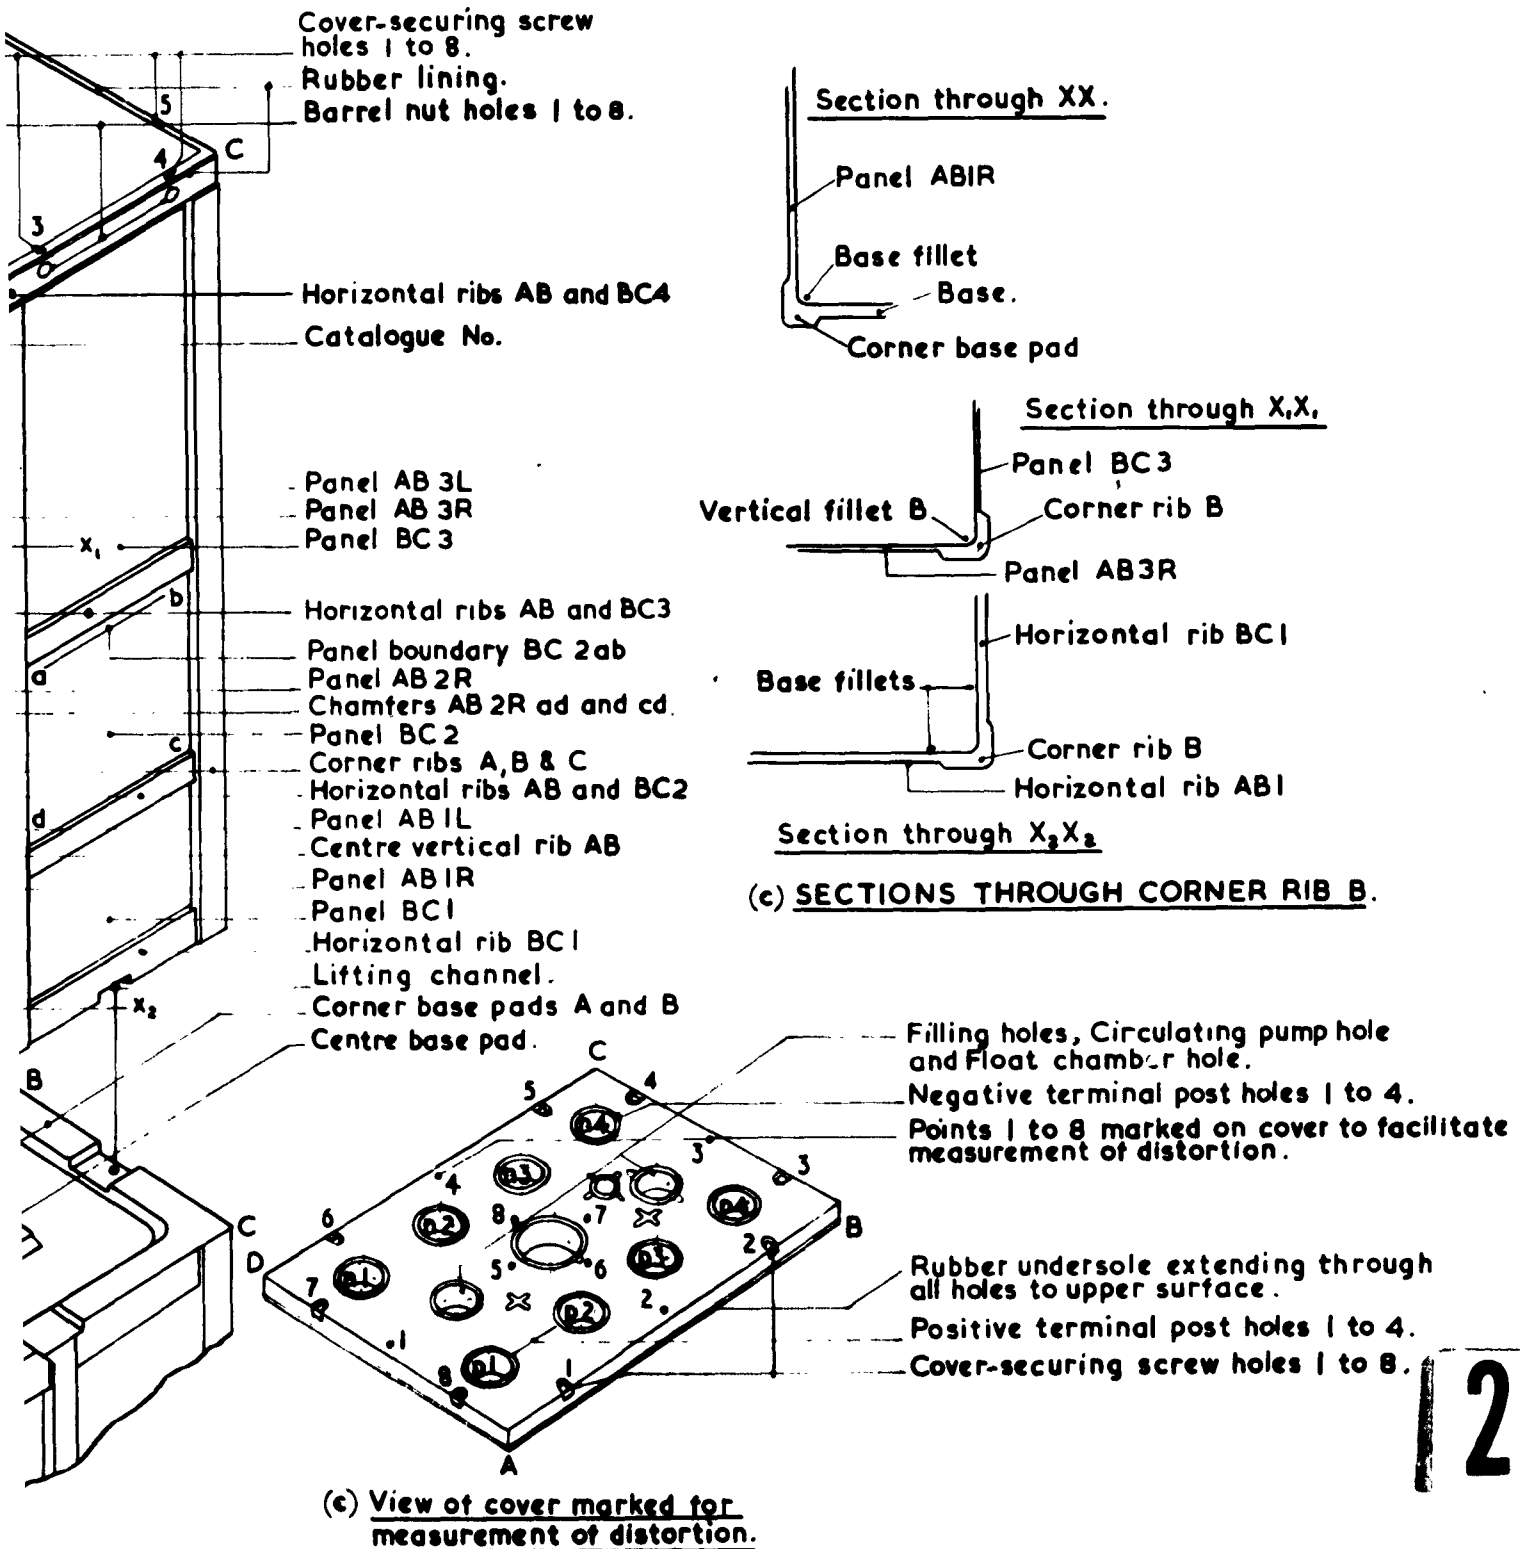
PARTS OF CONTAINER AND COVER.

(a) The parts of the container were identified as shown in Fig. 1. Marks were made on each side at the intersection of the centre lines of horizontal ribs Nos. 2 and 3 and the centre vertical rib, and the gaps between these marks and a straight edge laid horizontally across the container sides were measured before assembly.

parts of the container and the abbreviations used are shown in Fig. 1.

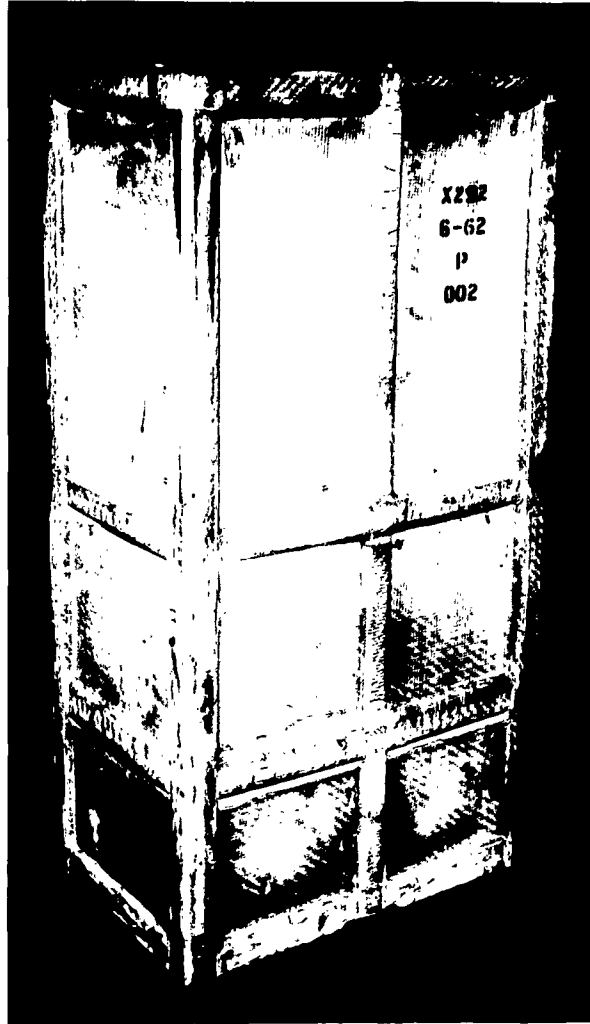
(a) Container after the shock test showing damage to centre vertical rib AB and to the boundaries of the panels.

5	4ft 6in.	Exterior	Seven narrow bands of opaque resin near top of centre vertical rib AB, short hair particles of surface resin descaled (Figs. 2(a) and 3(a)). Increase in damage to horizontal rib CD2 and a few additional, hairline cracks across centre vertical rib opaque at corners CD1 & 3L. Additional lifting of cloth and pattern more evident $1\frac{1}{2} \times \frac{3}{8} \times 1/64$ in. high). Further slight increase in opacity of resin along boundaries AB & CD 1Rb (typical of such damage) is given in Fig. 2(b) and Fig. 4(a).
		Interior	Further slight increase in opacity of the resin along the panel boundaries and slight surface resin descaled and fibres loosened and fluffed out along boundaries AB 1Rc (Fig. 4(b) and 3Lda. Between 10% and 40% of the fibres ruptured in the small area (Fig. 4(c)); CD 1L & Rb. Resin opaque and pattern of weave slightly raised also

ue resin near top of centre vertical rib AB, short hairline cracks along the middle area of these bands and a few a descaled (Figs. 2(a) and 3(a)). Increase in damage to sub-surface resin of centre vertical rib CD below few additional, hairline cracks across centre vertical rib above horizontal rib CD3. Small areas of surface resin L. Additional lifting of cloth and pattern more evident at wales at these corners and at CD1 & 2Rb (all wales about Further slight increase in opacity of resin along boundaries of panels of side BC. Views of the damage at corners uch damage) is given in Fig. 2(b) and Fig. 4(a).
